Name of School Poolesville H.S

2021 AHERA 3 Year Reinspection summary form

Inspection Date: 8/10/21

POOLSVILLE HIGH SCHOOL

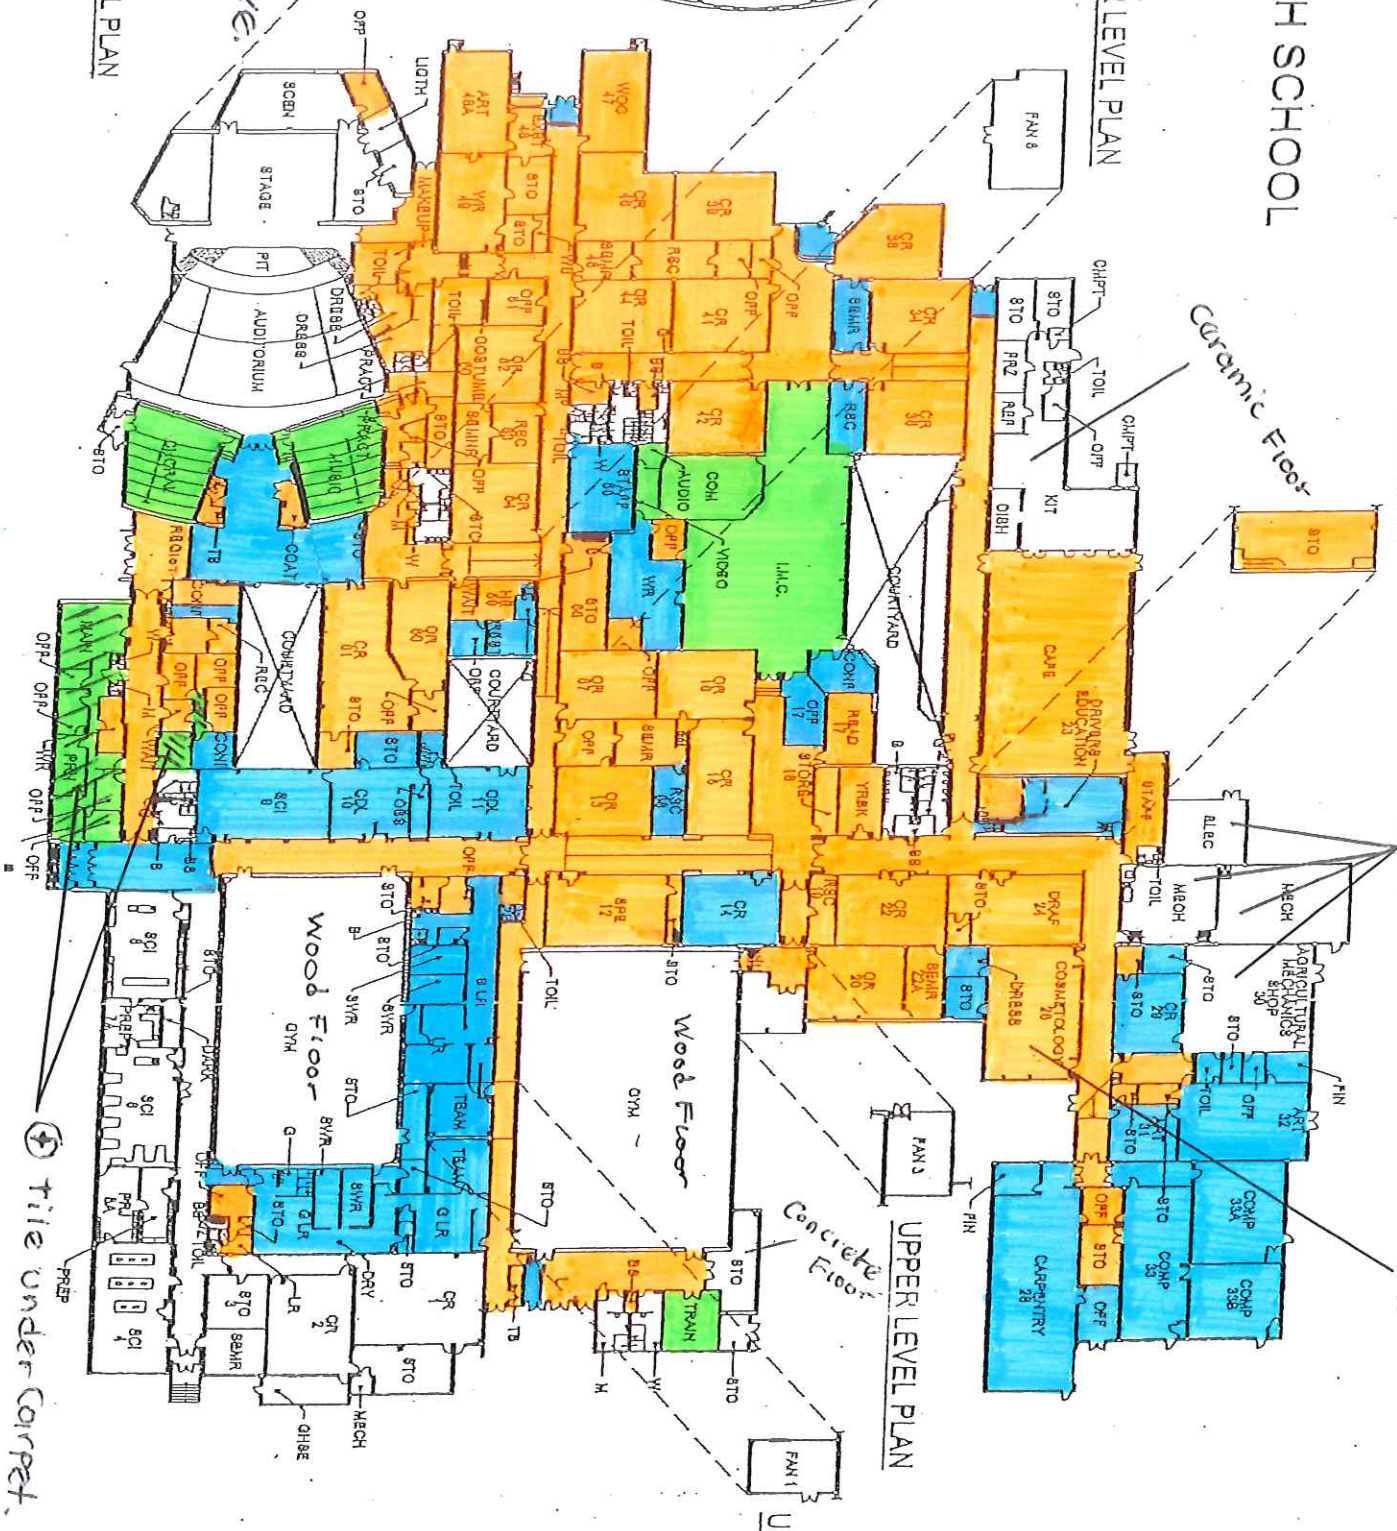
MAIN LEVEL PLAN

* FT/Mastic
under cabinets/finishes
Assumed to be positive.
(throughout).

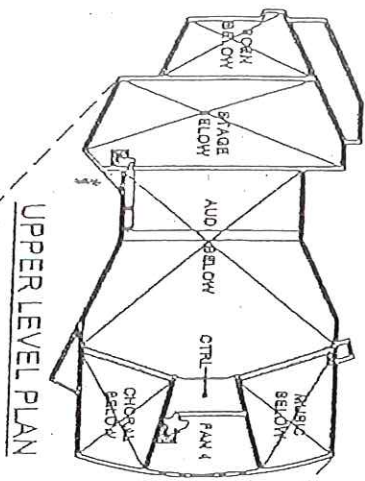
* ⊕ TSI PIPE and Elbows,
Air cell PIPE. UPPER LEVEL PLAN

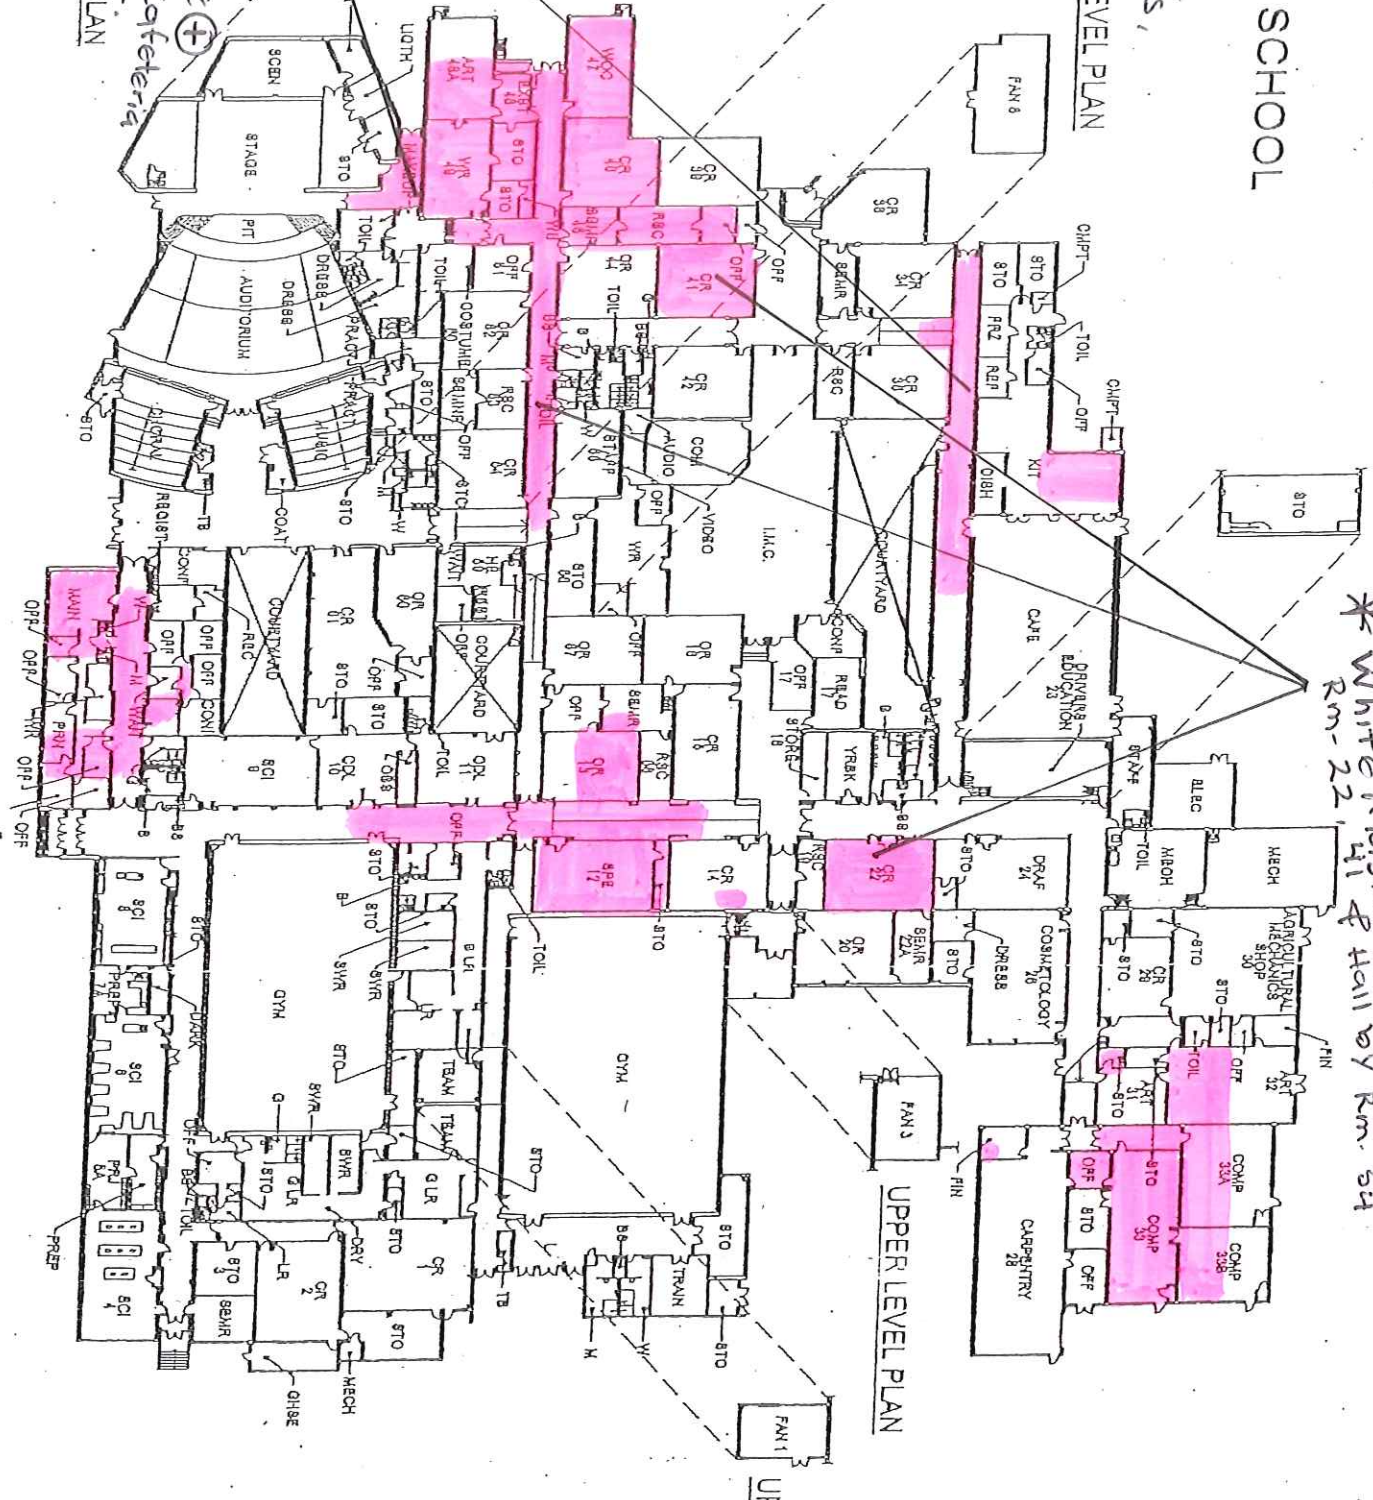
* White Mastic on Pipe ⊕
on this areas. Hall by cafeteria
Hall back stage door & exit.
MAIN LEVEL PLAN

* White Mastic on duct ⊕ on this areas.
Rm. 22, 41 & Hall by Rm. 54

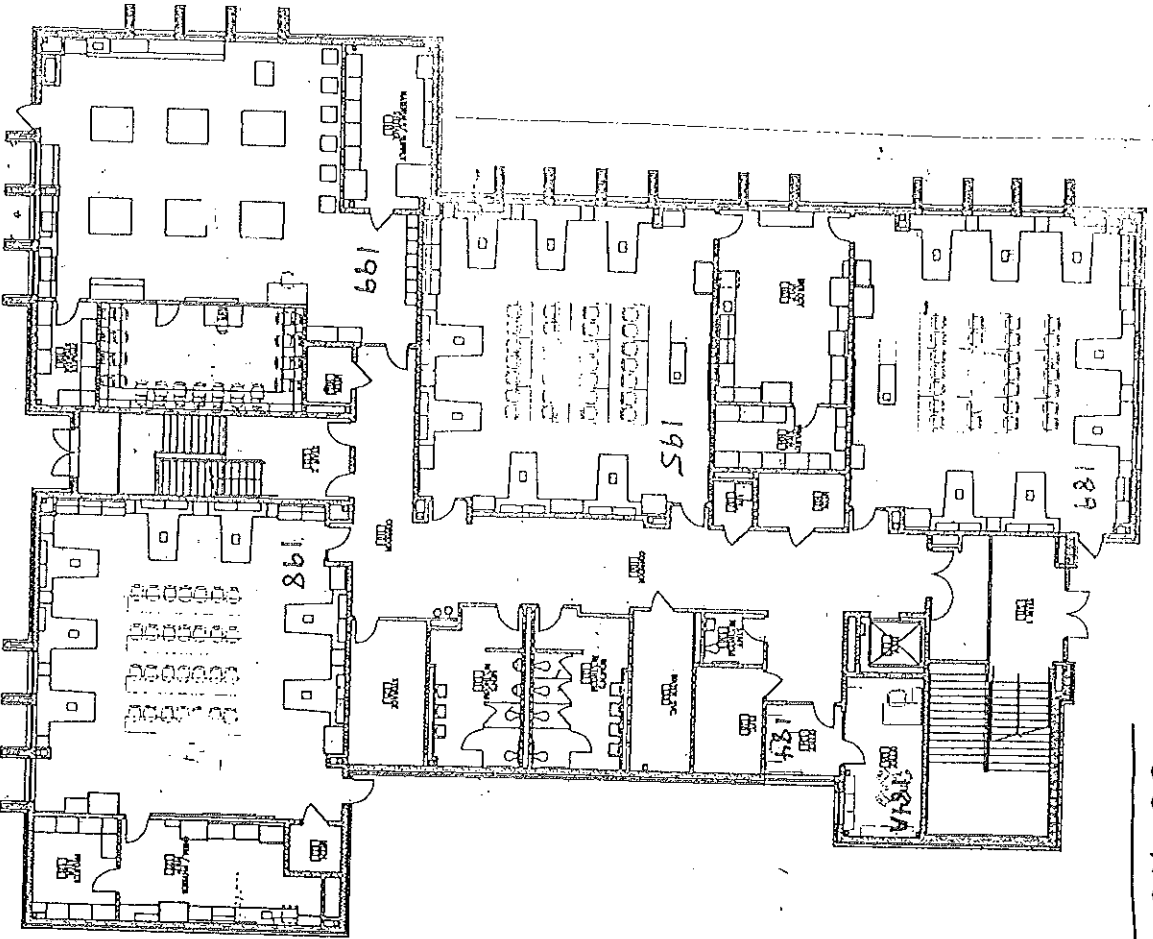
POLESVILLE High School
Science/Technology Addition

Addition Exclusion 2009
