LEAD-BASED PAINT SCREENING REPORT

**Grosvenor Center
5701 Grosvenor Ln
Bethesda, MD 20814**

Date of Report: April 12, 2018

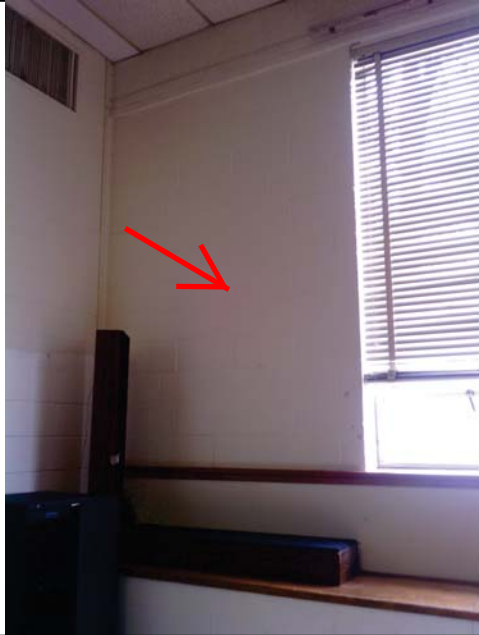
Picture 1: White CMU Wall

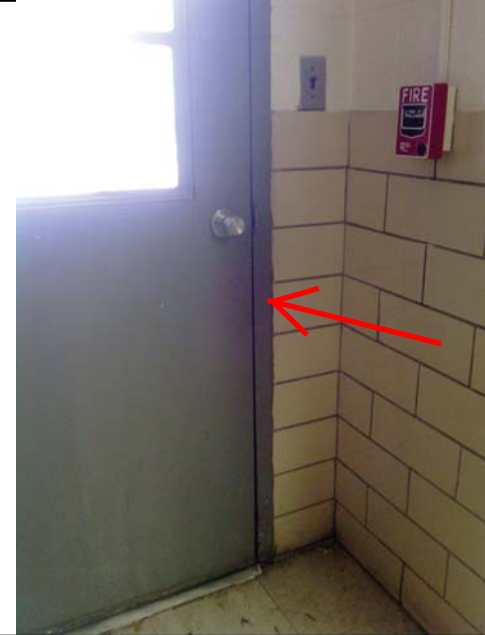
Picture 2: Grey Metal Door Casing

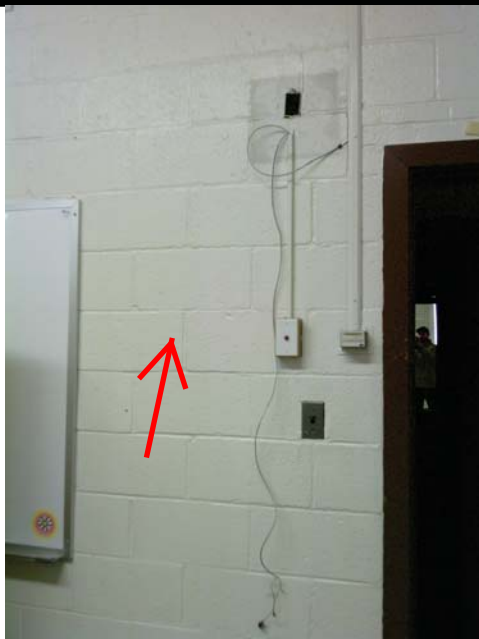
Picture 3: White CMU Wall

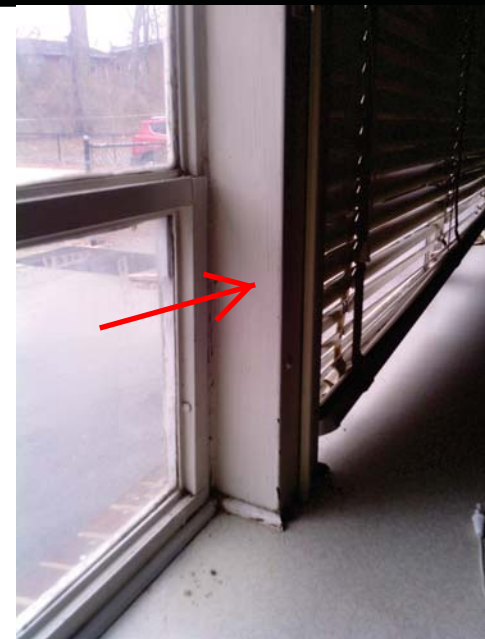
Picture 4: White Metal Window Casing

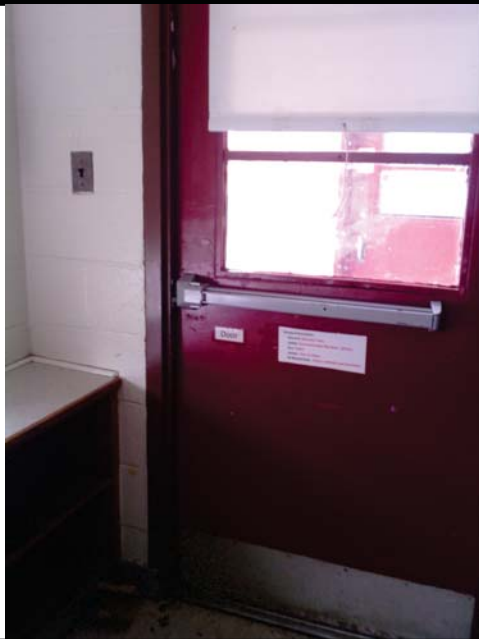
Picture 5: Red Metal Door and Casing

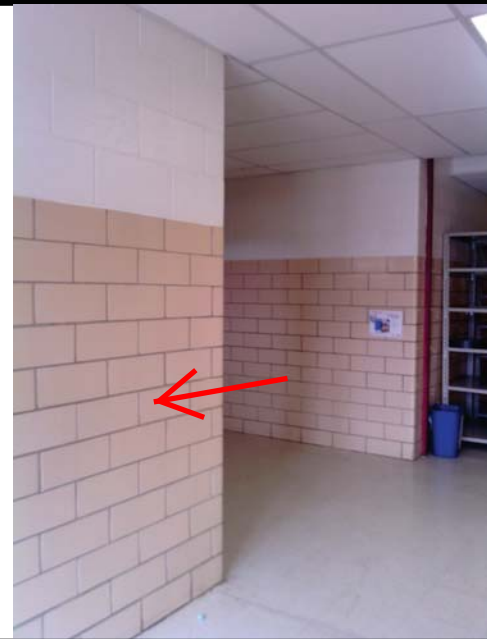
Picture 6: Tan CMU Wall

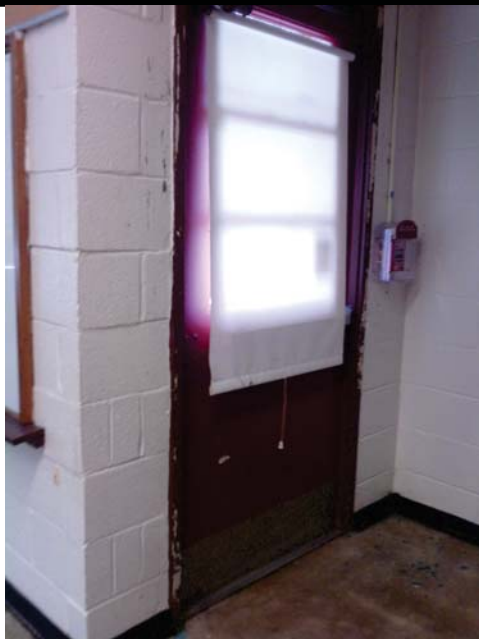
Picture 7: Red Metal Door

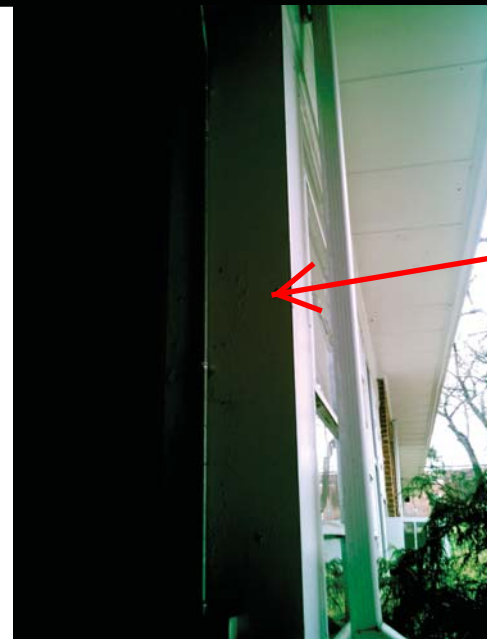
Picture 8: White Metal Wall Casing

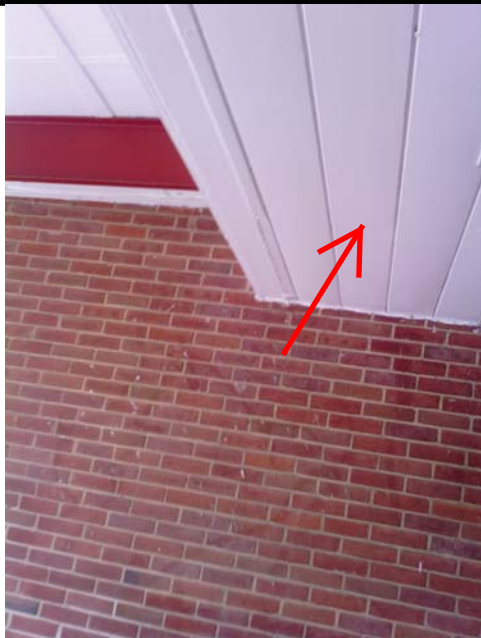
Picture 9: White Wood Portico Ceiling

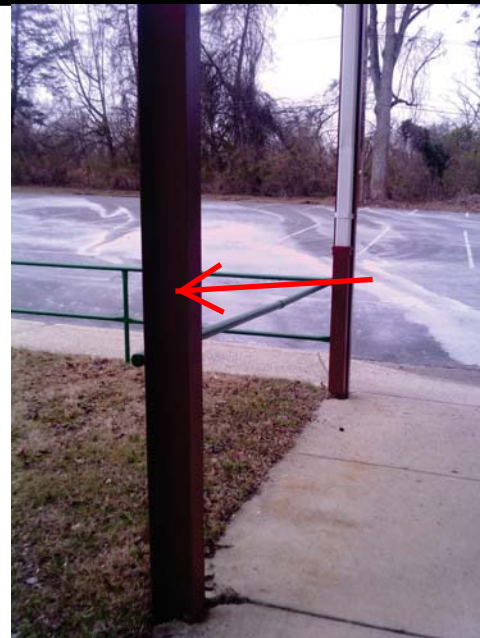
Picture 10: Red Metal Column

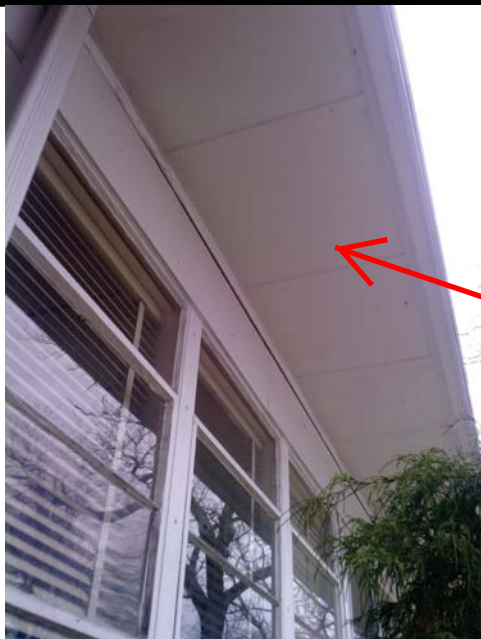
Picture 11: White Wood Soffit

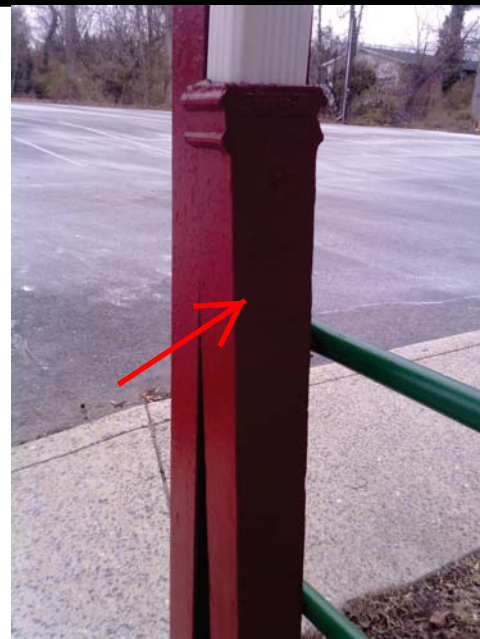
Picture 12: Red Metal Gutter Pipe

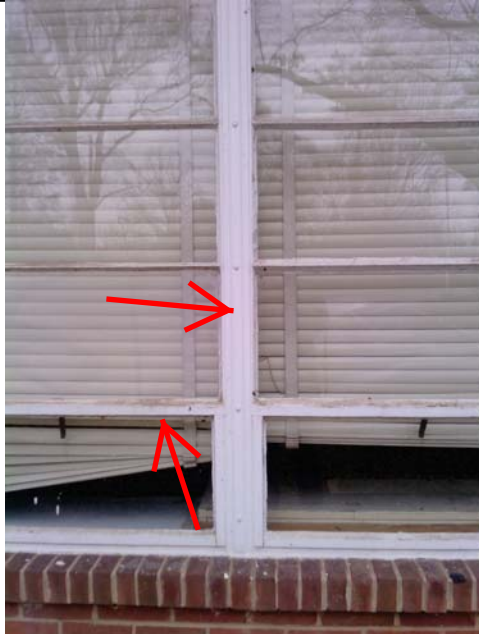
Picture 13: White Metal Window Casing

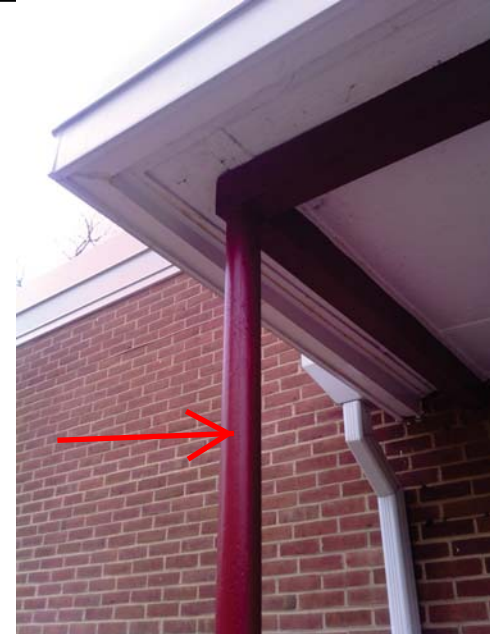
Picture 14: Red Metal Column

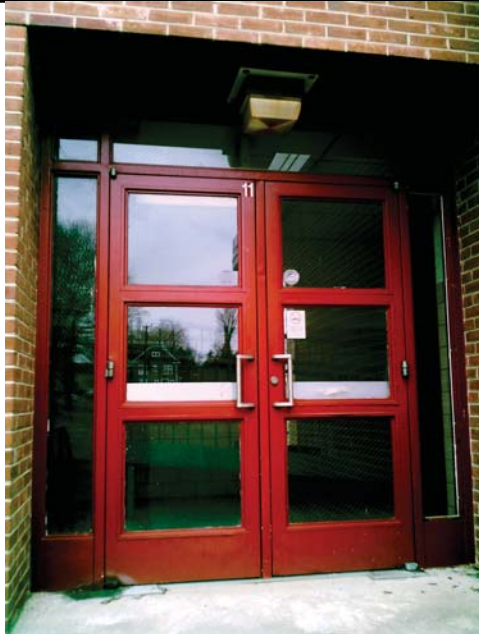
Picture 15 Red Metal Door

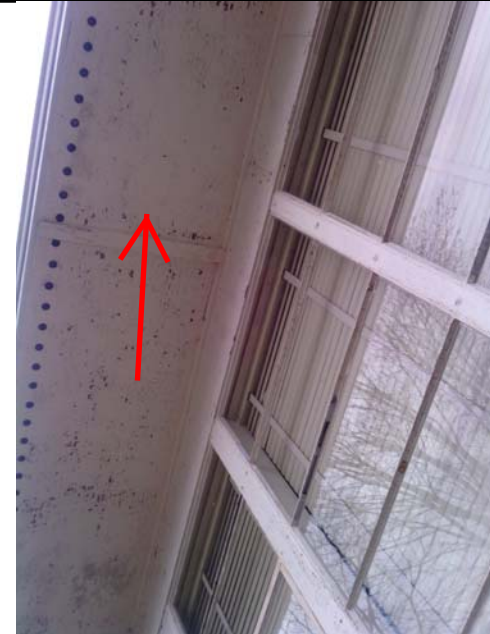
Picture 16: White Wood Soffit

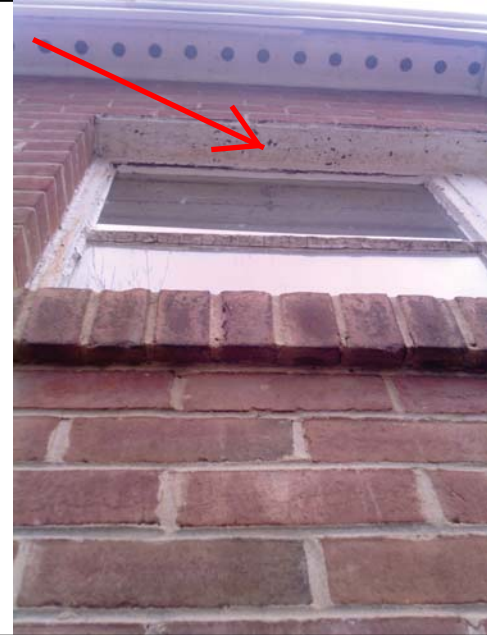
160	Metal	Window	Lintel	White	A	Exterior	1.5	Deteriorated	18

Picture 18: White Metal Window Lintel
